NTSB National Transportation Safety Board

Office of Aviation Safety

Flight Crew Performance: Operational Factors

Captain David Tew Operations Group Chairman

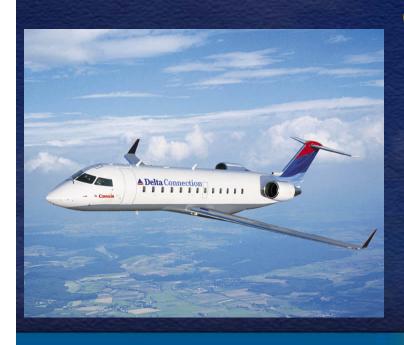
- Captain required to conduct a taxi briefing
 - Airport diagram
 - Extra care crossing runways
- Abbreviated briefing
- First flight as a crew

- First officer briefed "taxi to runway 22 via taxiway alpha"
 - Runway end lights out
 - "Lights out all over the place"
- Did not include crossing runway 26
